Aviation Investigation Final Report

Location: Boston, Massachusetts Incident Number: DCA23LA192

Date & Time: February 27, 2023, 18:54 Local **Registration:** N280LJ (A1); N179JB

Aircraft: LEARJET INC 60 (A1); Embraer ERJ

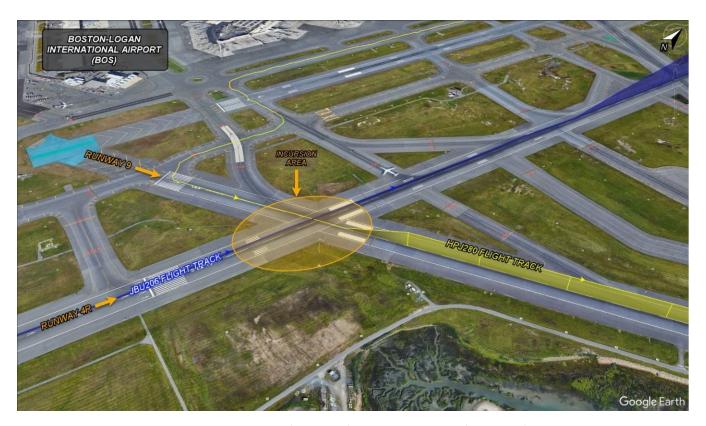
JBU206's flight crew initiated a go-around while over runway 04R, prior to reaching the intersection with runway 09. The closest proximity between both airplanes occurred when JBU206 was about 30ft AGL during the landing flare, close to the point where both runways intersected, see figure 1. A video file taken by the occupant of the flight deck observer seat was provided to the NTSB and a screen capture from the video is shown in figure 2.

Figure 1. Flight tracks of both JetBlue (JBU206) and Hop-a-Jet (HPJ280) with yellow circle indicating incursion area.

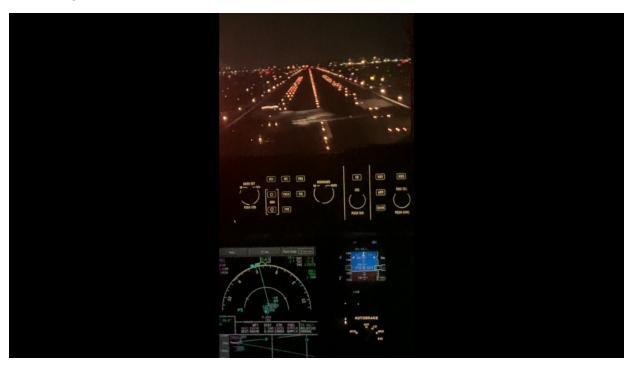
Figure 2: Screen capture from jump-seat occupant's video recording showing Lear 60 crossing runway centerline.
